Apollo Bay sand movement

Coastal geomorphology, coastal processes and the management of coastal hazards from Marengo to Skenes Creek

Coastal Management Fact Sheet 2.4

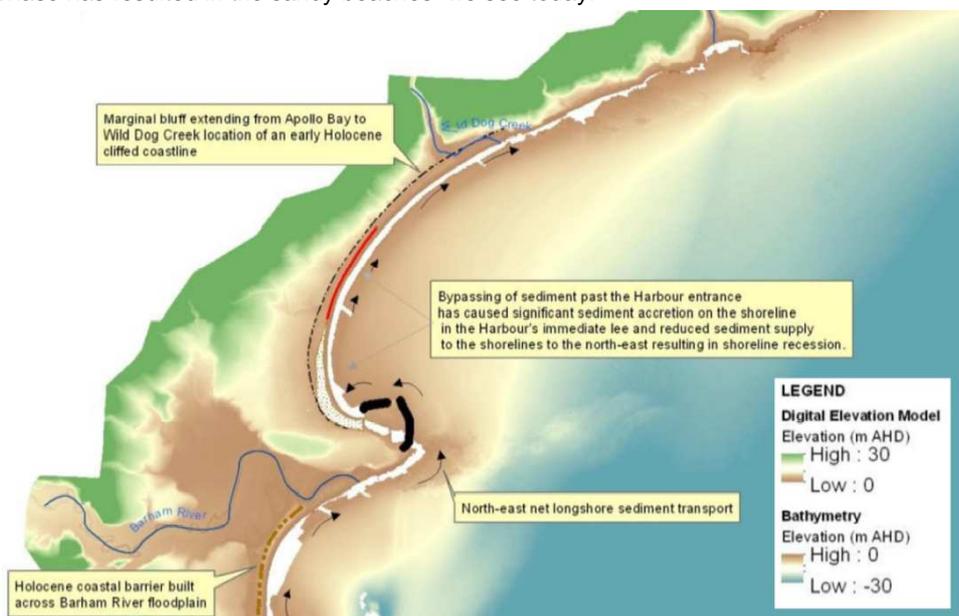
Figure 1: Apollo Bay sand movement

The beaches of Apollo Bay are in a constant state of change. Following seasonal variations in wave, current and wind processes (littoral drift processes), net movement of sand is estimated to be 80,000m³ to the north east annually.

The construction of the Apollo Bay Harbour in 1956, and two years later the Point Bunbury groynes, disrupted the longshore transport of sand to the north. The change to sand transportation is further characterised by the wave shadow that the harbour creates. This change in wave direction and energy results in segments of the Apollo Bay foreshore either eroding or accreting.

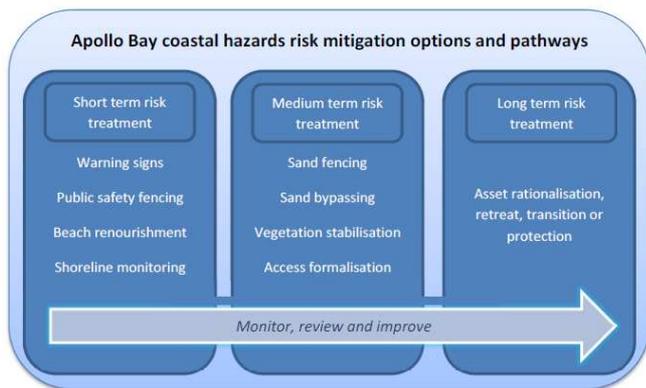
Figure 2: Risk treatment

Severe erosion events are cyclical and the capacity for the beach to recover is reliant on the resilience of that coastal system. Implementation of a comprehensive range of strategies offers the most effective treatment of risk brought on by coastal hazards.

Where possible the use of 'soft engineering' options such as sand carting can accelerate the recovery process. Sand sources and how much sand can be removed before there are residual impacts (removal capacity) have been identified for Apollo Bay. Soft engineering options provide both maintenance and event mitigation solutions. (see Coastal Management Fact Sheet 2.2).

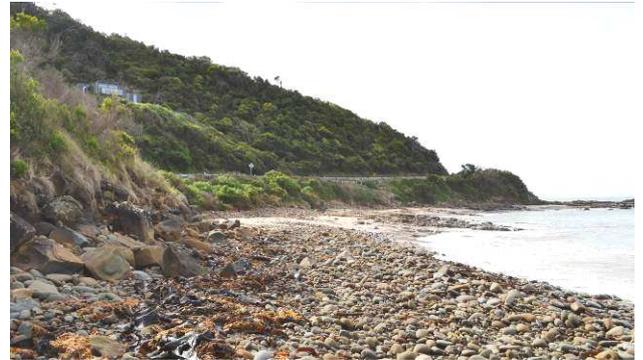
Figure 3: Separation Creek foreshore August 2011

Often no direct intervention is required other than the immediate management of public safety. Not far from Apollo Bay, Separation Creek provides an example of where the beach eroded during the storm surges of winter 2011 and has recovered naturally.
