# Managing beach erosion at Marengo and Apollo Bay

Marengo sand nourishment – May and June 2017

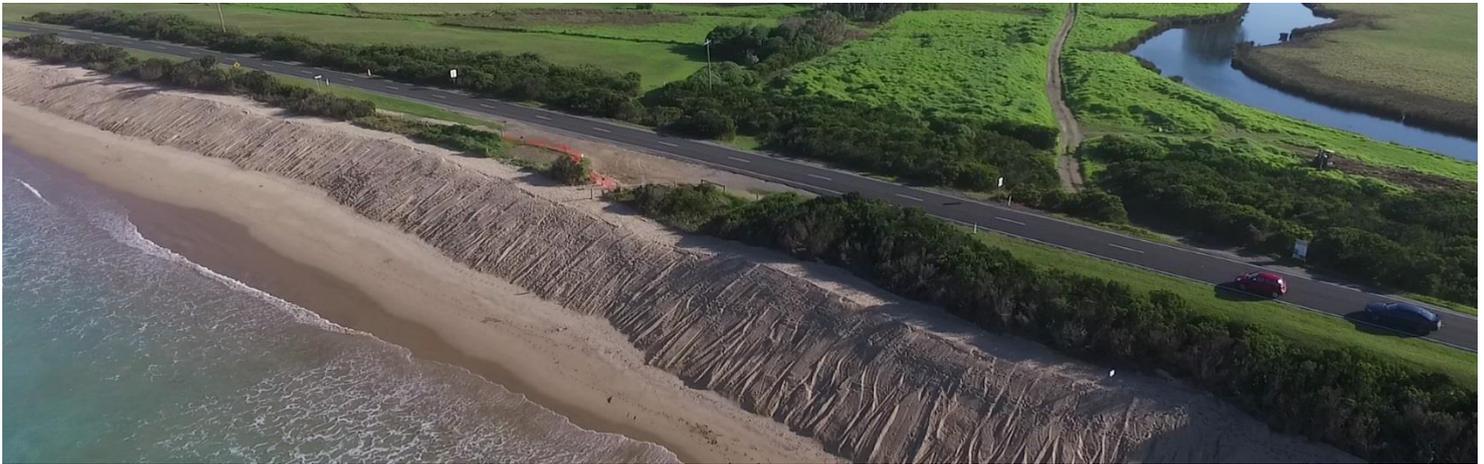
The Department of Environment, Land, Water and Planning (DELWP) and the Otway Coast Committee Inc., supported by Barwon Water, Colac Otway Shire and VicRoads, have undertaken sand nourishment at Mounts Bay, Marengo. Around 16,000m<sup>3</sup> was carted from nearby harvest areas - the Barham River Spit and Point Bunbury. This sand was used to create a new dune at the erosion site along Mounts Bay Beach. Sand was deposited along 600 metres of the beach and increased the dune width by 10 to 15 metres.

Since the work was completed, winter swells have impacted the beach and eroded the new dune site. The dune is performing as expected, acting as a buffer to the previously eroded foreshore.

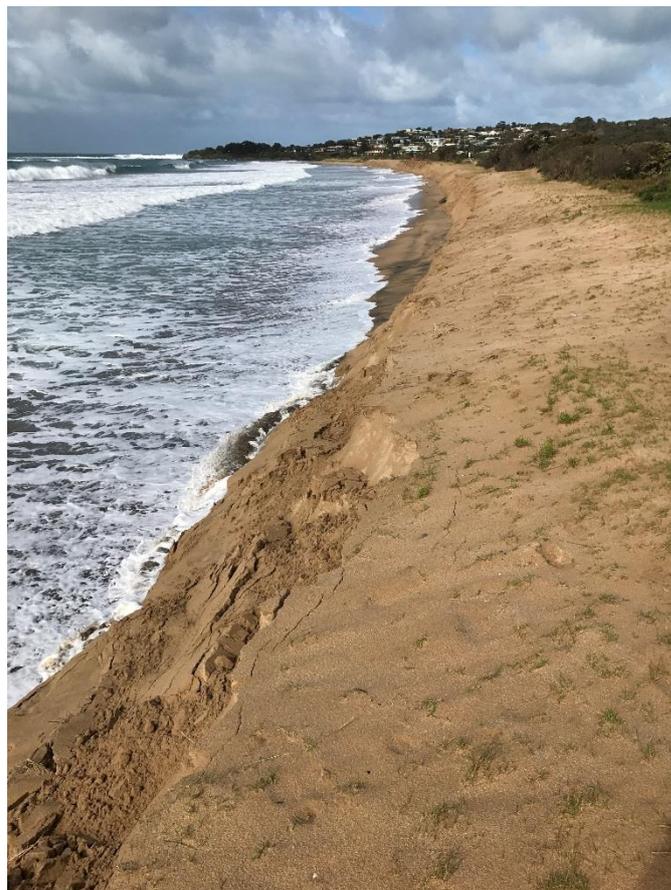
Above: Sand nourishment site during winter swell.  
Left: Coconut husk 'coir' logs mid-winter.

- Coconut husk 'coir' logs and jute matting was placed on the dune accompanied by planting of local coastal dune species.
- Sterile Rye Corn seed was scattered on the top of the dune to trial its effectiveness as a soil/ sand stabiliser.
